**TRANSPORTATION SCIENCES CENTER
ACCIDENT RESEARCH GROUP**

**CALSPAN ON-SITE AIR BAG DEPLOYMENT INVESTIGATION
CALSPAN CASE NO. 94-14
VEHICLE: 1994 OLDSMOBILE NINETY EIGHT REGENCY ELITE
LOCATION: [REDACTED]
CRASH DATE: [REDACTED], 1994**

14. Sponsoring Agency Code	
15. Supplementary Notes On-site investigation of an air bag deployment crash that resulted in multiple fractures to the right hand of the right front passenger of a 1994 Oldsmobile Ninety Eight as she attempted to brace against the air bag module cover flap.

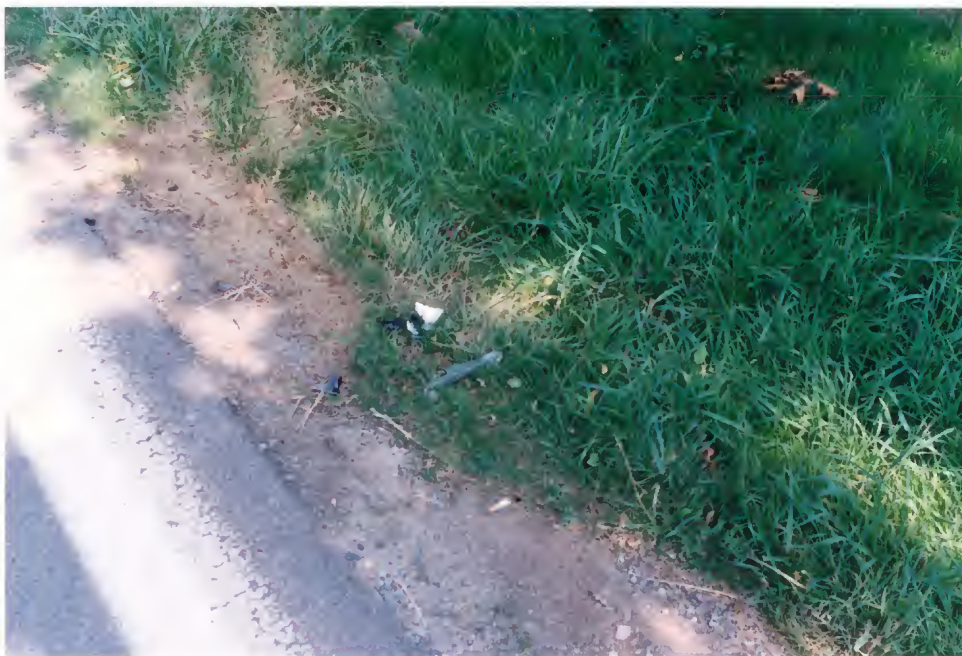
5. Probable debris at scene.

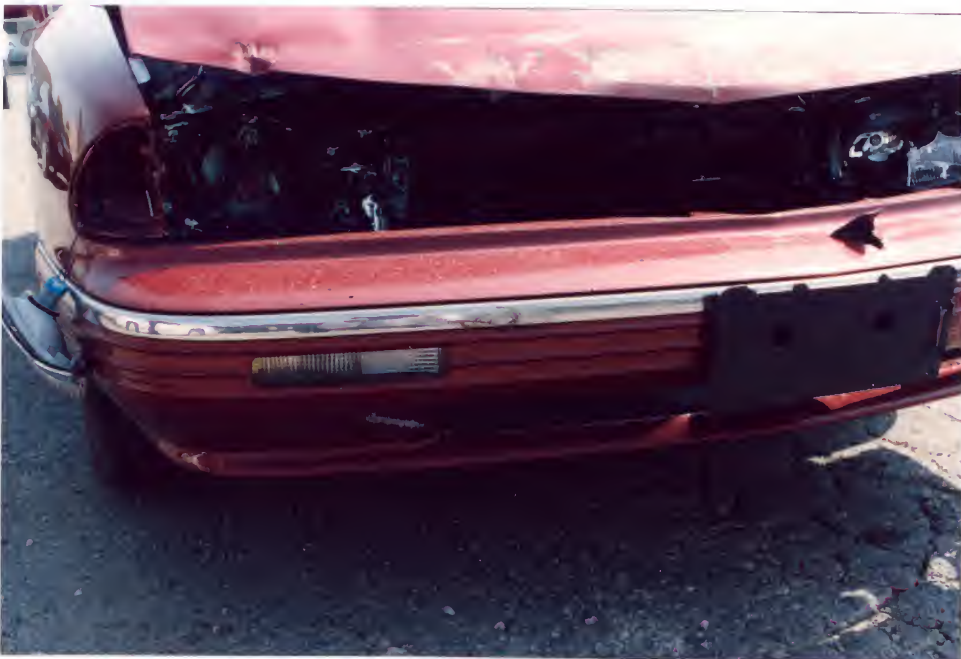
10. Close-up view of the face of the right front bumper fascia.

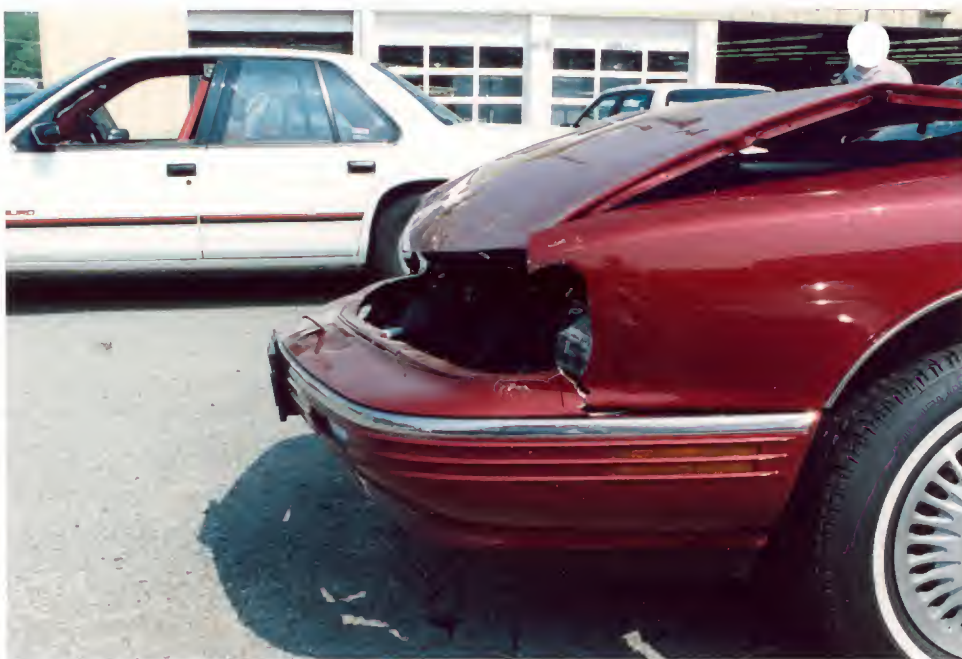
12. Perpendicular view of the hood displacement.

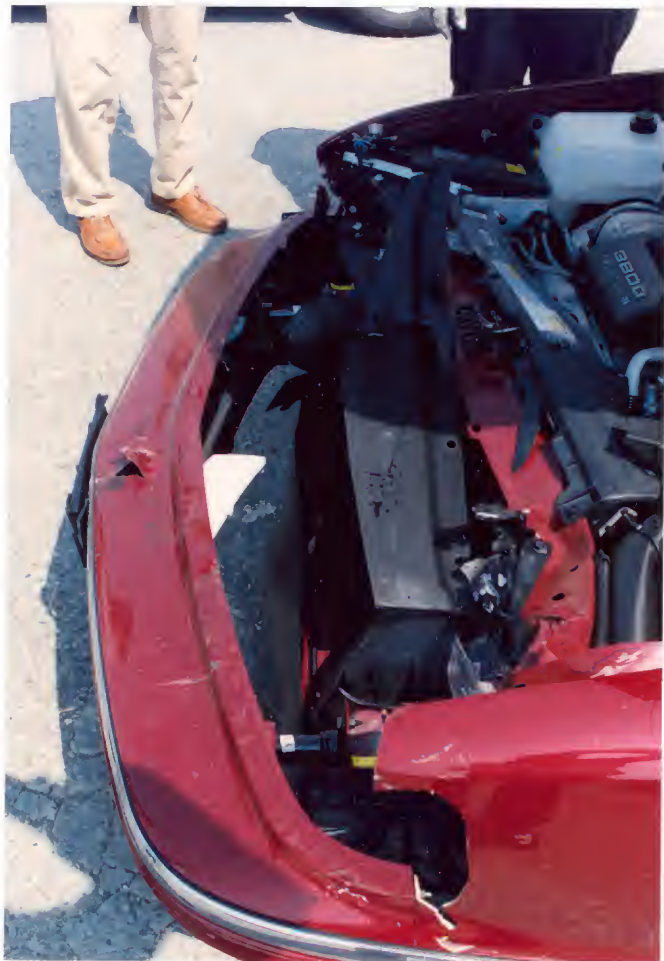
13. Perpendicular view of the crush to the upper radiator support.

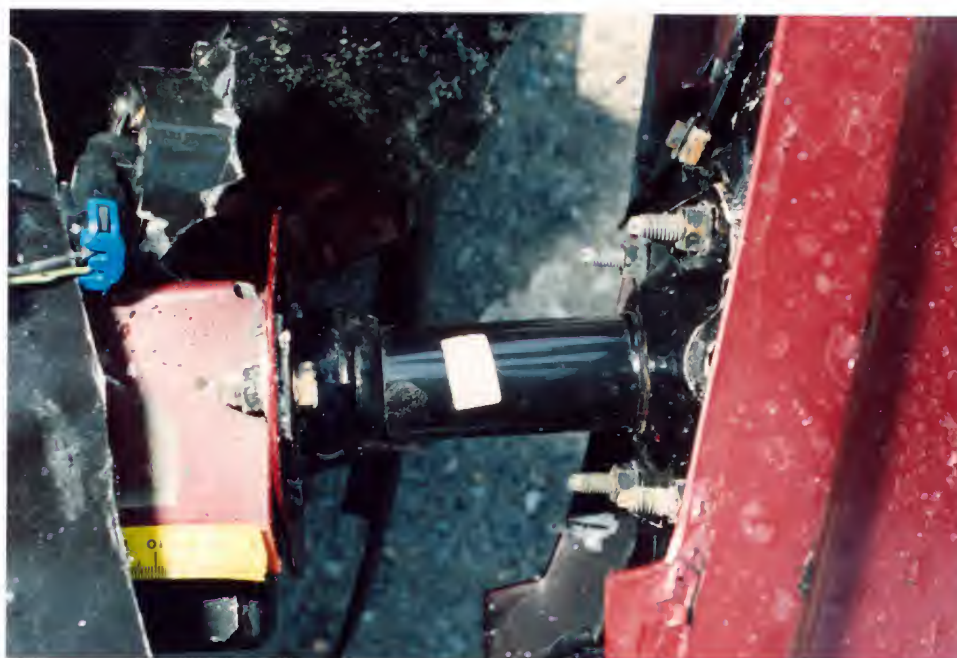
16. Right front bumper EAD (no compression).

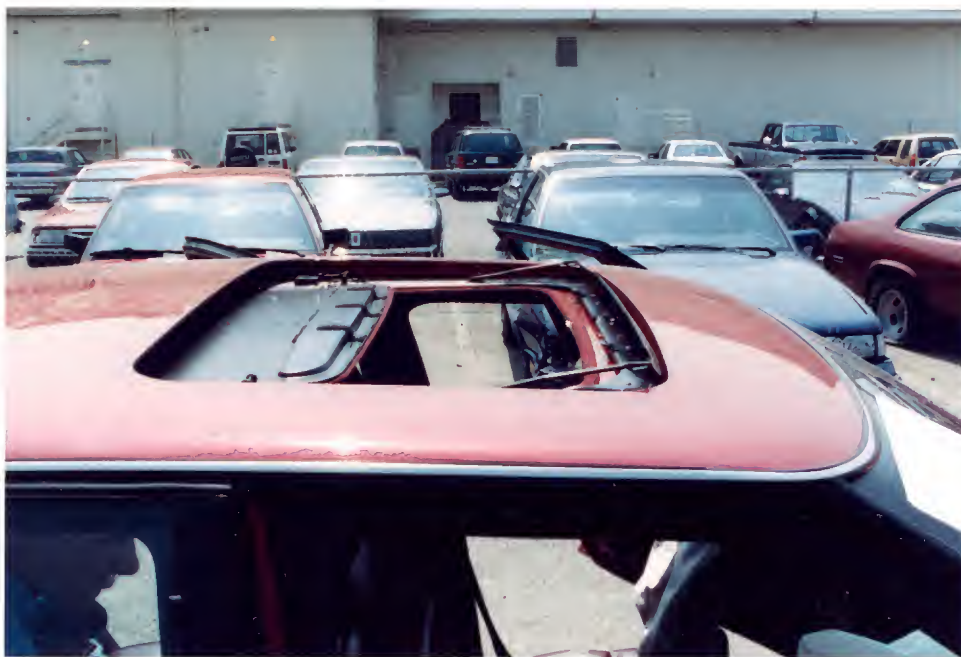
25. Tempered glass sun roof separated from the vehicle.

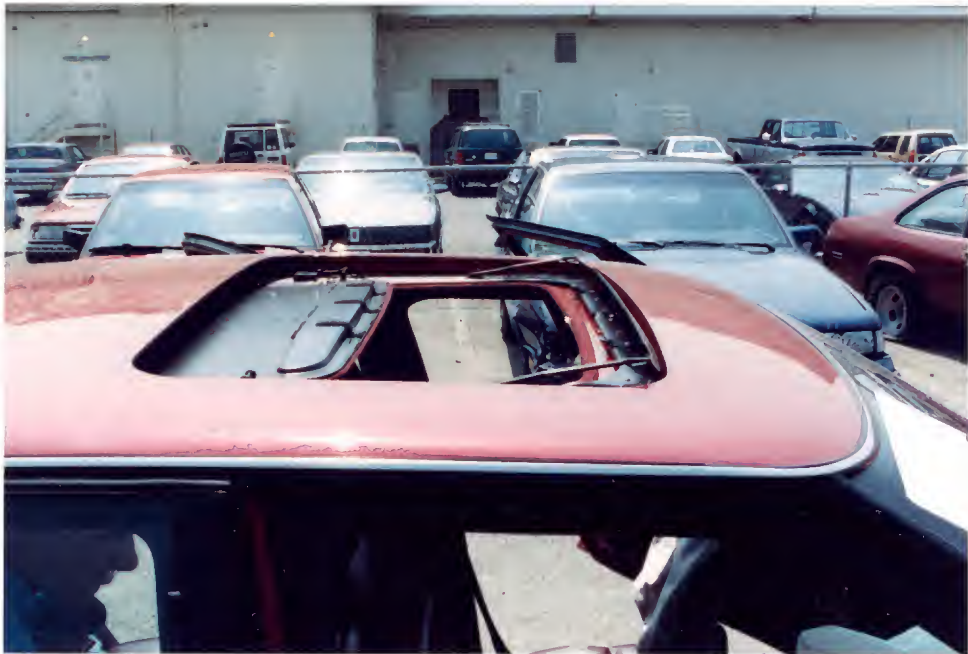
25. Tempered glass sun roof separated from the vehicle.

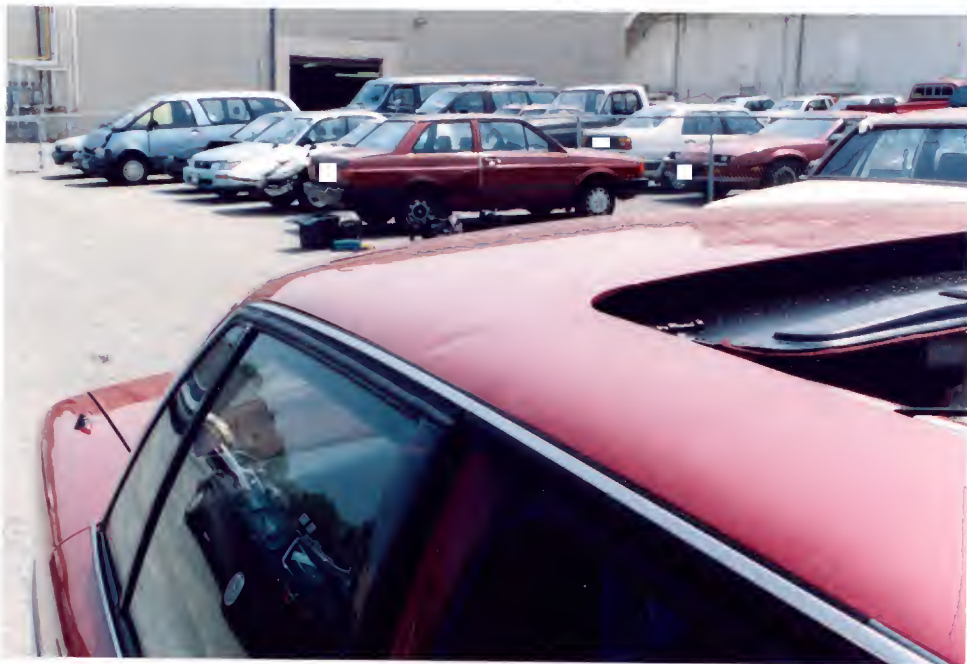
The 1994 Oldsmobile Ninety Eight sustained moderate frontal damage as a result of its front-to-rear impact sequence with the stopped Ford Ranger (vehicle #2). In an attempt to avoid the crash, the driver of the Oldsmobile applied a braking force which compressed the front suspension as the vehicle impacted the rear of the stopped Ford Ranger. The top surface of the front bumper fascia initially impacted then underrode the rear step bumper of the pickup truck. Damage to the fascia consisted of longitudinally oriented abrasions to top surface and a tear located 7.6 cm (3.0") left of the center that resulted from the trailer hitch stud protruding from the center of the rear bumper of the Ford Ranger. The center-mounted license plate frame was cracked as a result of the contact sequence. There was compression of the bumper energy absorbing devices (EADs) and no residual crush at bumper level. Both front bumper EADs remained in their original pre-crash position at 8.6 cm (3.375") in length (refer to Photograph Nos. 15 and 16). As the front bumper of the Oldsmobile underrode the rear bumper of the Ford Ranger, the grille and hood face area engaged against the bumper face and tailgate of the Ford Ranger. The direct contact damage was 140.0 cm (55.1") in length which extended across the entire width of the vehicle at grille level. The contact fractured the plastic grille and headlamp assemblies and deformed the air conditioning condenser, the center mounted air bag discriminating sensor, and the upper radiator support panel. Maximum crush was 25.1 cm (9.875") located at the radiator support panel 38.1 cm (15.0") left of center (refer to Photograph Nos. 13 and 14). The residual crush profile was documented at the upper radiator support level and was as follows: $C_1 = 9.1$ cm (3.6"), $C_2 = 24.4$ cm (9.6"), $C_3 = 19.7$ cm (7.75"), $C_4 = 16.8$ cm (6.6"), $C_5 = 14.2$ cm (5.6"), $C_6 = 2.3$ cm (0.9"). The leading edge of the hood sustained contact damage from engagement with the tailgate of the struck Ford Ranger. The contact damage began 12.1 cm (4.75") inboard of the right corner and extended 134.6 cm (53.0") to the left corner (refer to Photograph No. 7). The tempered glass sunroof separated from the vehicle and was found lying undamaged in the rear seat area of the vehicle. The roof sustained symmetrical areas of deformation directly rearward of the B-pillars on both sides of the vehicle (refer to Photograph Nos. 21 and 26).

26. Induced deformation to the roof at the right B-pillar area.

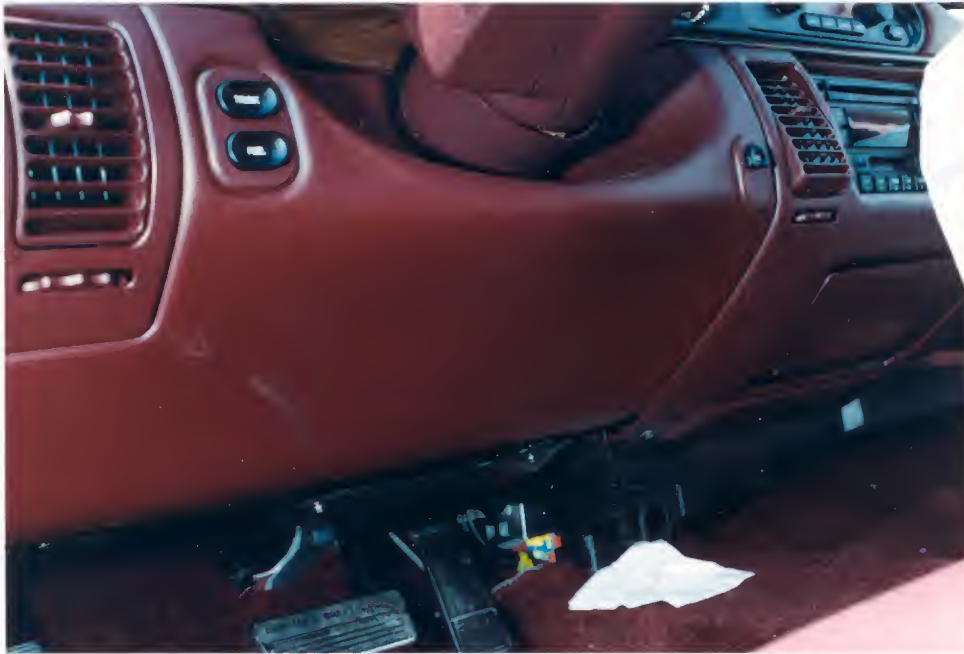
31. Knee bolster with probable foot scuff on left side.

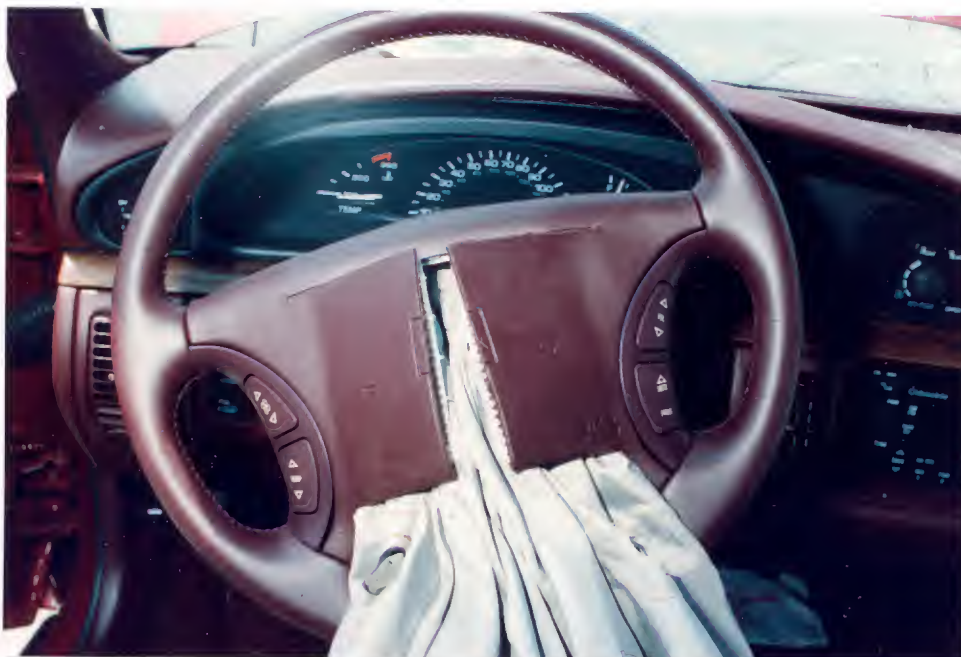
34. Vertical configuration of the driver's side air bag module cover flaps.

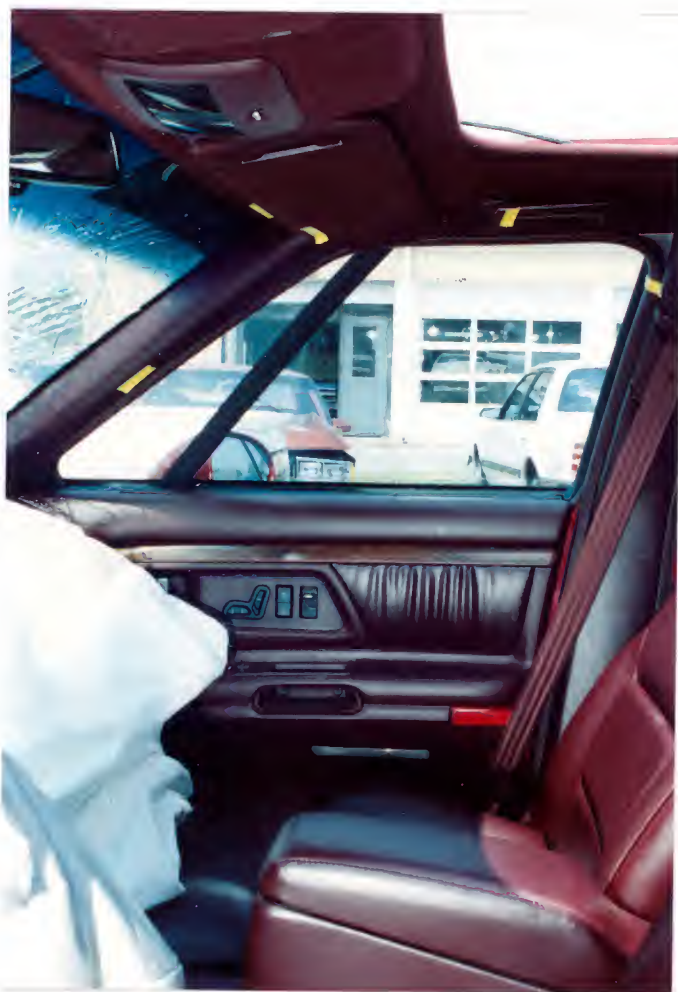
37. Perpendicular view across the interior to the right door area.

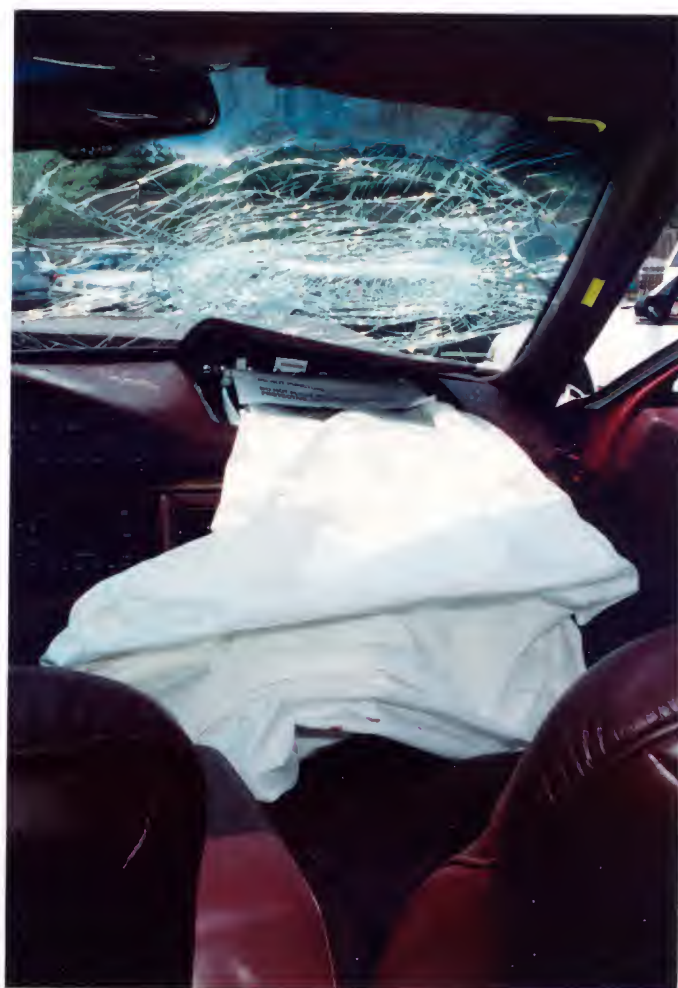
38. Overall view of the right front passenger compartment and deployed air bag.

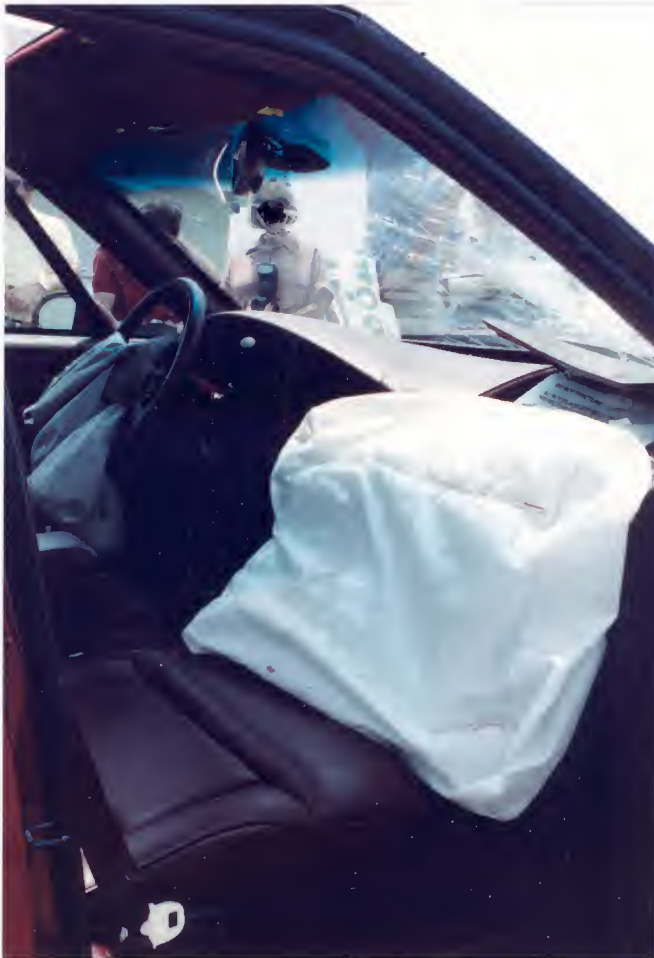
39. Deployed passenger side air bag.

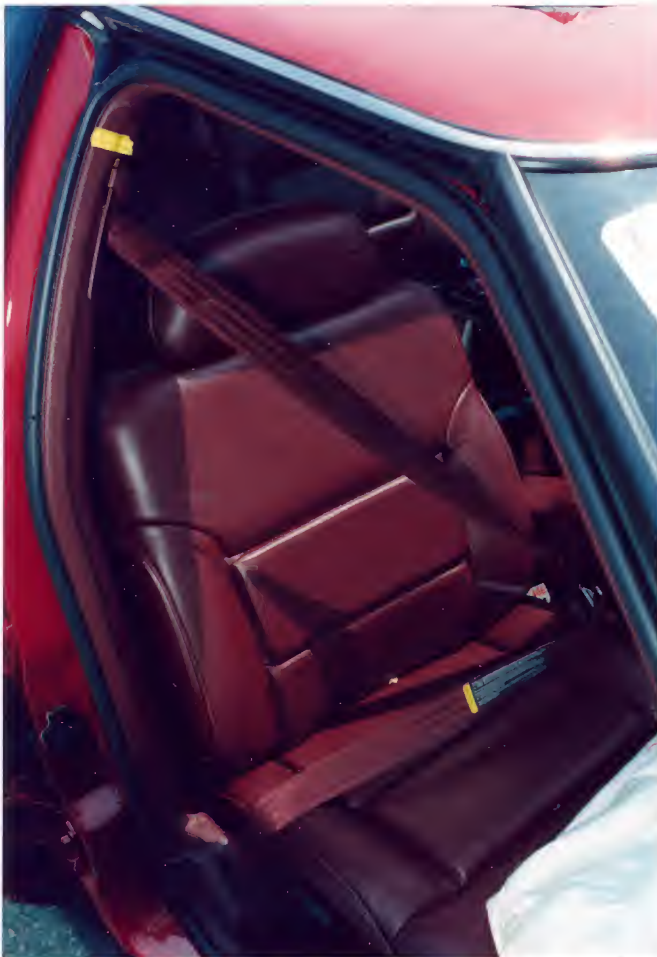
48. Passenger's seat and the manual 3-point belt system.

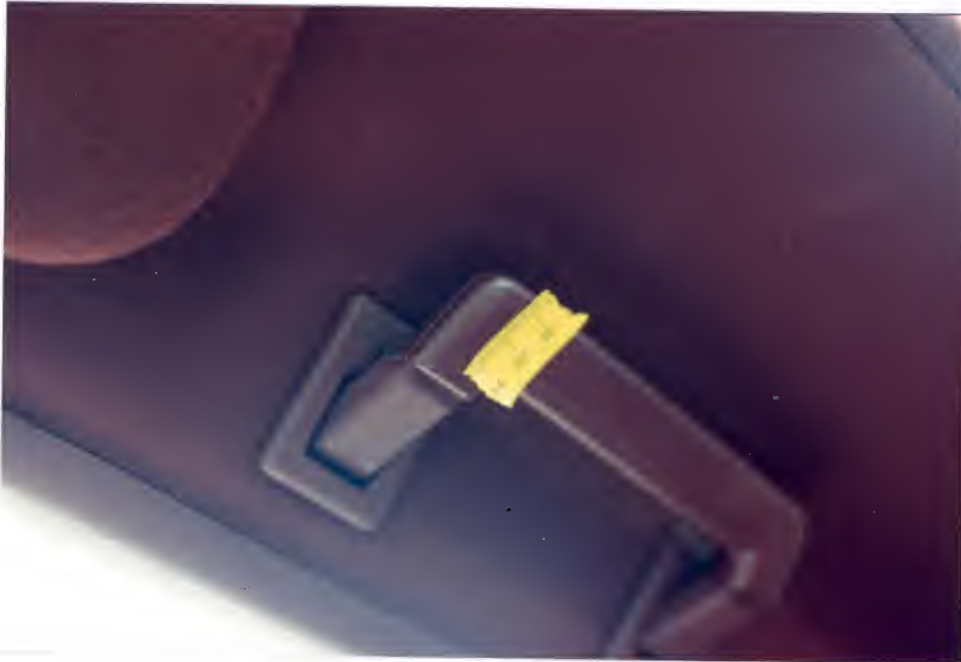
51. Scuff on the leading edge of the roof mounted right passenger assist grip.

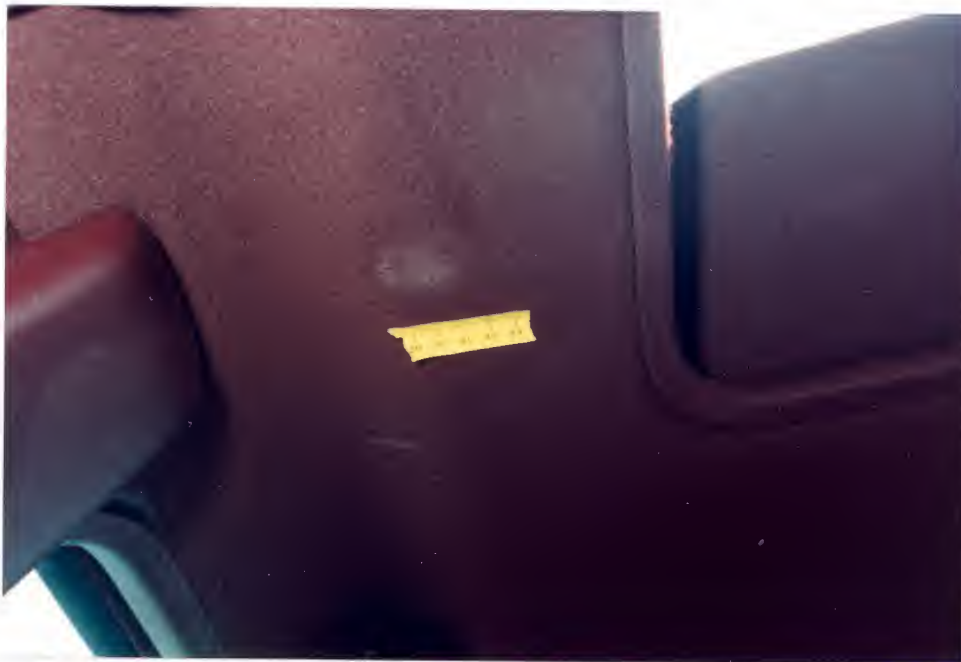
52. White powder transfer on the headliner inboard of the right B-pillar.

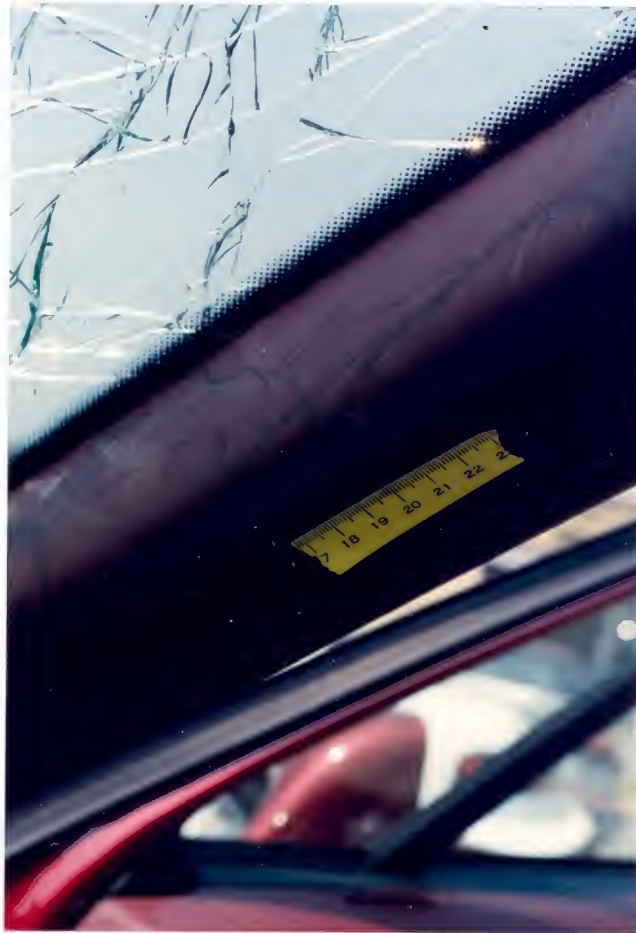
53. Scuff at the mid point
of the right B-pillar.

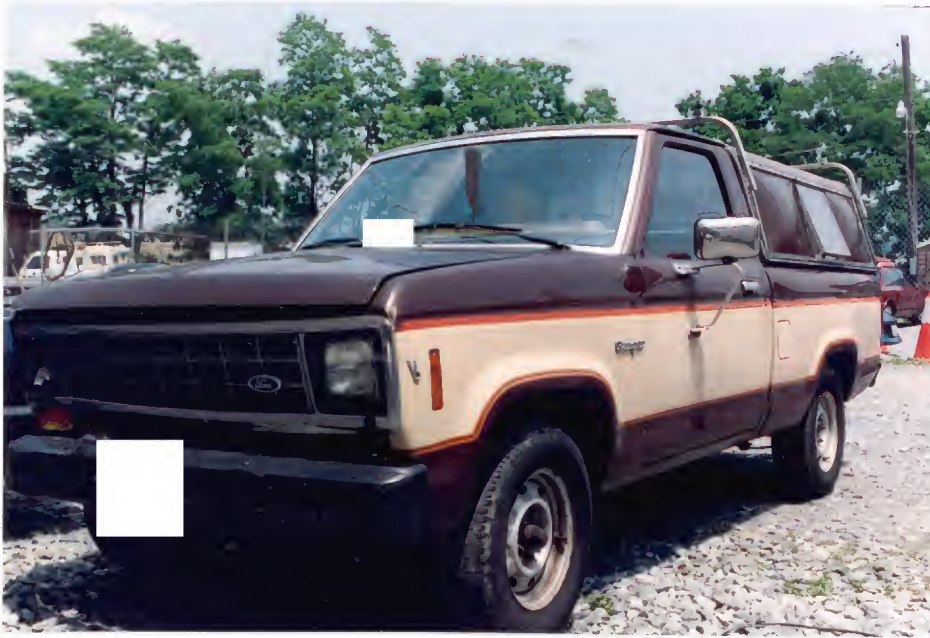
The 1983 Ford Ranger sustained full-width direct contact damage of 153.0 cm (60.25") to the lower portion of the rear bumper. The rear bumper was an original equipment manufacture (OEM) type step bumper with a ball hitch bolted to the mid point. Maximum crush was 7.3 cm (2.9") located on the lower right corner area. The crush profile was as follows: $C_1=5.1$ cm (2.0"), $C_2=2.8$ cm (1.1"), $C_3=1.5$ cm (0.6"), $C_4=1.9$ cm (0.75"), $C_5=5.1$ cm (2.0"), $C_6=7.3$ cm (2.9"). The vehicle damage profile is documented in Photograph Nos. 55- 58. The hood of the Oldsmobile engaged against the lower tailgate of the Ford Ranger, however, there was no contact damage to the tailgate. Paint transfers were noted to the hood face of the Oldsmobile from tailgate contact. Minor right frontal damage resulted to the Ford Ranger from its subsequent impact sequence with the stopped Nissan Pathfinder (vehicle #3). The damage consisted of bumper deformation at the right corner, right headlight and grille damage, and right front fender crush.

54. Left frontal view of the struck Ford Ranger.

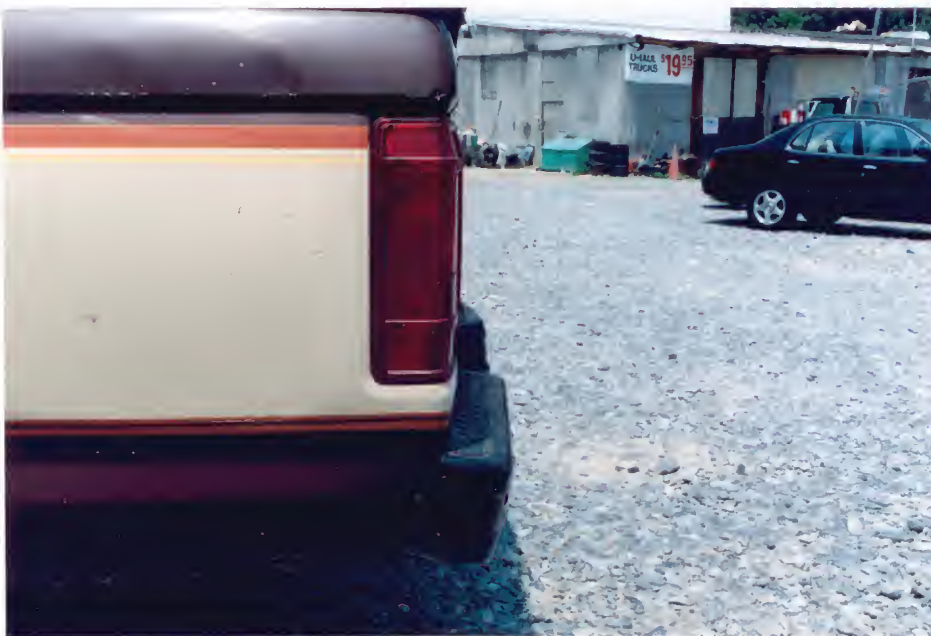
56. Perpendicular view of bumper crush at the left rear corner.

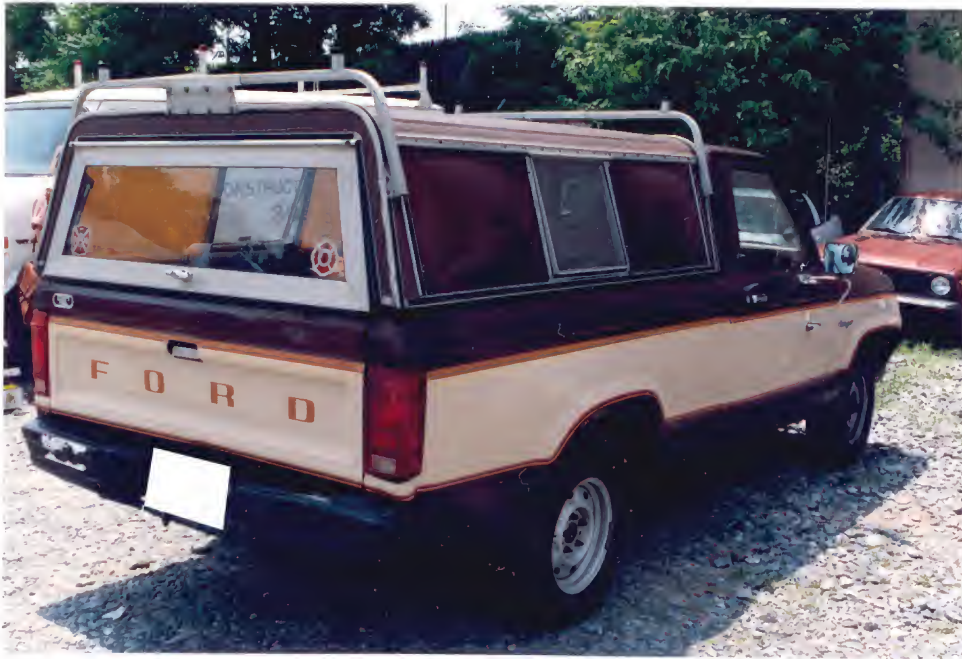
59. Right rear three-quarter view.
